DPF/FAP/CAT filter REGENERATION/CLEANING

Date of service: 2017-09-05

Vehicle make and model: Audi a5

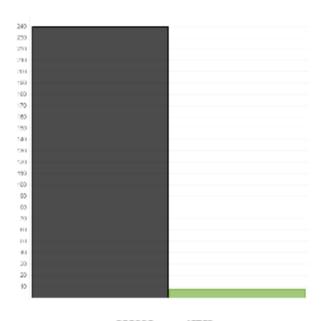
PRESSURE DIAGRAM
Pressure drop by 96.67%

2. Pressure measurement: before [240] after [8] mbar

BEFORE AFTER
PRESSURE DIAGRAM

Pressure drop by 232.00 mbar
